### Inspection Report

#### Minerals Regulatory Program

**Mine Name:** D Tract

**Permit number:** S/047/068

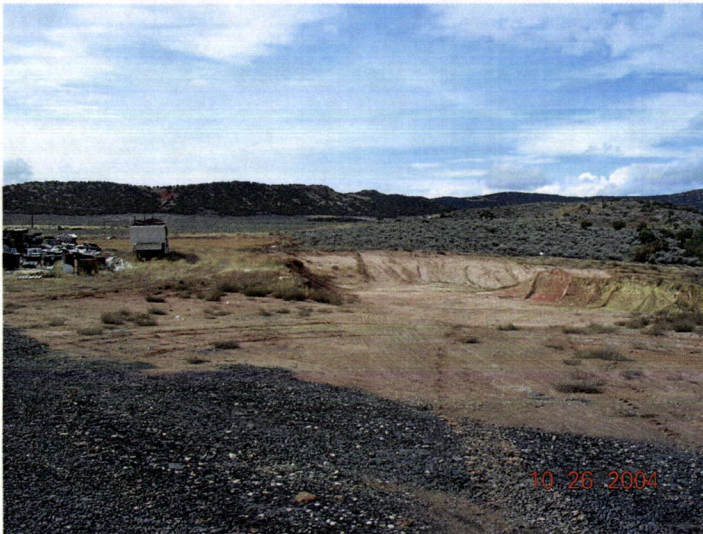
**Photo 1. An area from which sand has been mined for addition to the asphalt.**

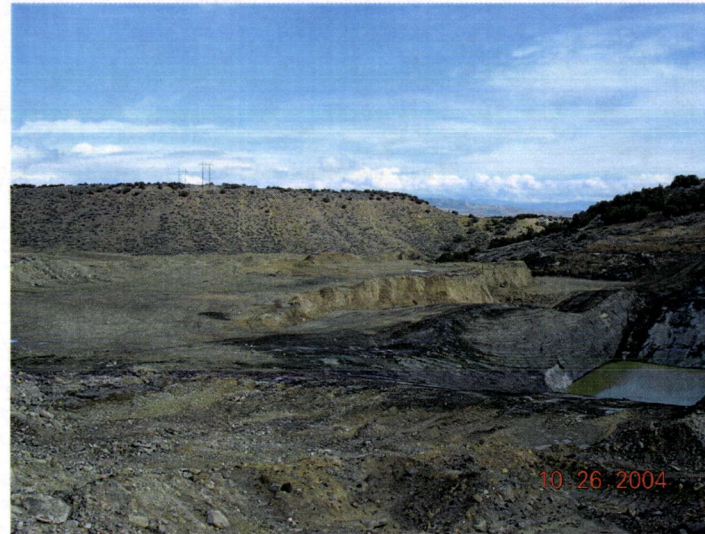
**Photo 3. The mine pit and some of the area to the north. Note the water in the pit. Overburden has been dumped in an area toward the north of the pit (to the left in this photo).**

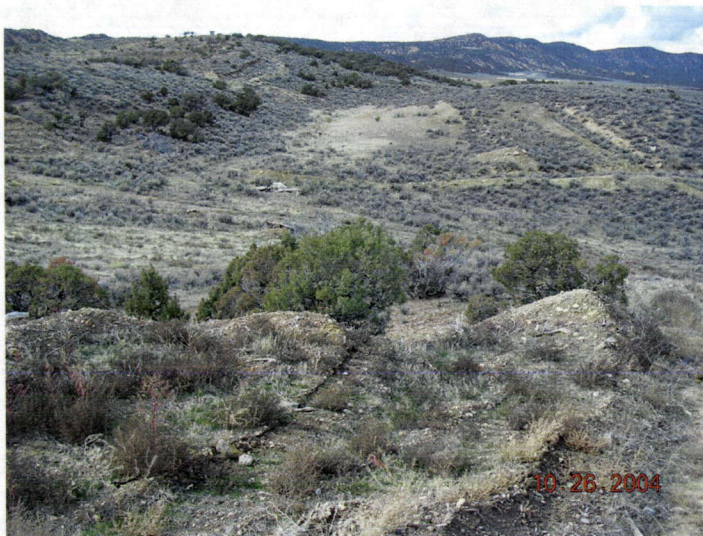
**Photo 2. A portion of the "reclaimable area." The area has been disturbed, but there has been no mining here.**

The operator was required to reclaim the "reclaimable area" as shown on the map, but this has not yet happened. Mr. Allred is willing to do this work and has purchased the seed, but there are negotiations for another operator to purchase the land. If another operator was to begin operations, chances are good he would expand the mine to the west into the "reclaimable area." Mr. Allred does not want to reclaim the area only to have it redisturbed. Although I do not know how serious these sale negotiations are or who the potential buyers are, I have confirmed that two entities have discussed purchasing the property.

Based on these concerns, Mr. Allred asked if the Division could delay the requirement for reclaiming the "reclaimable area" until about January 2005.

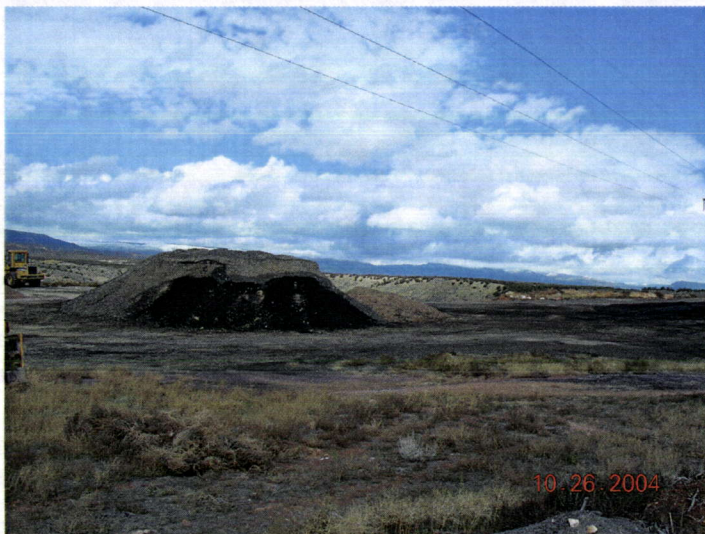
**Photo 4. Native asphalt from the mine.**

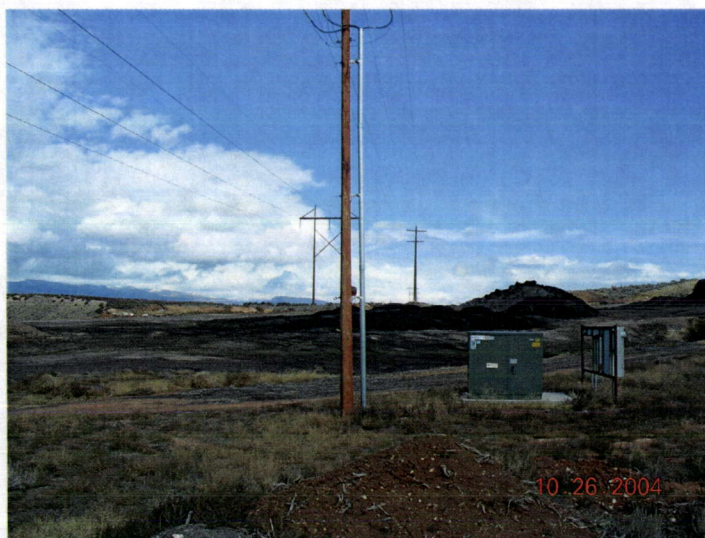
**Photo 5. The asphalt in this photo is being recycled and is not from the mine.**

Within the rest of the area I mapped, the "processing" area (with the exception of the included mixing area) and the "recycling" area are now both being used exclusively for recycling asphalt. Even if the mine was not present, the operator could still recycle asphalt at this location.

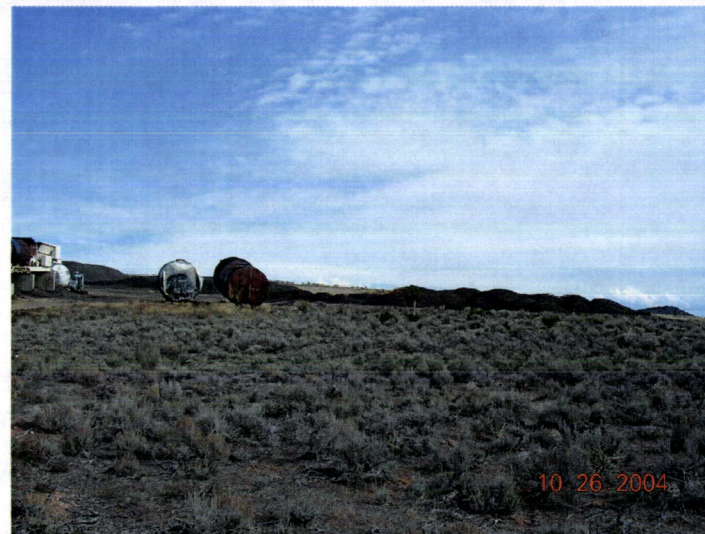
**Photo 6. The asphalt across the center of this photo is being recycled.**

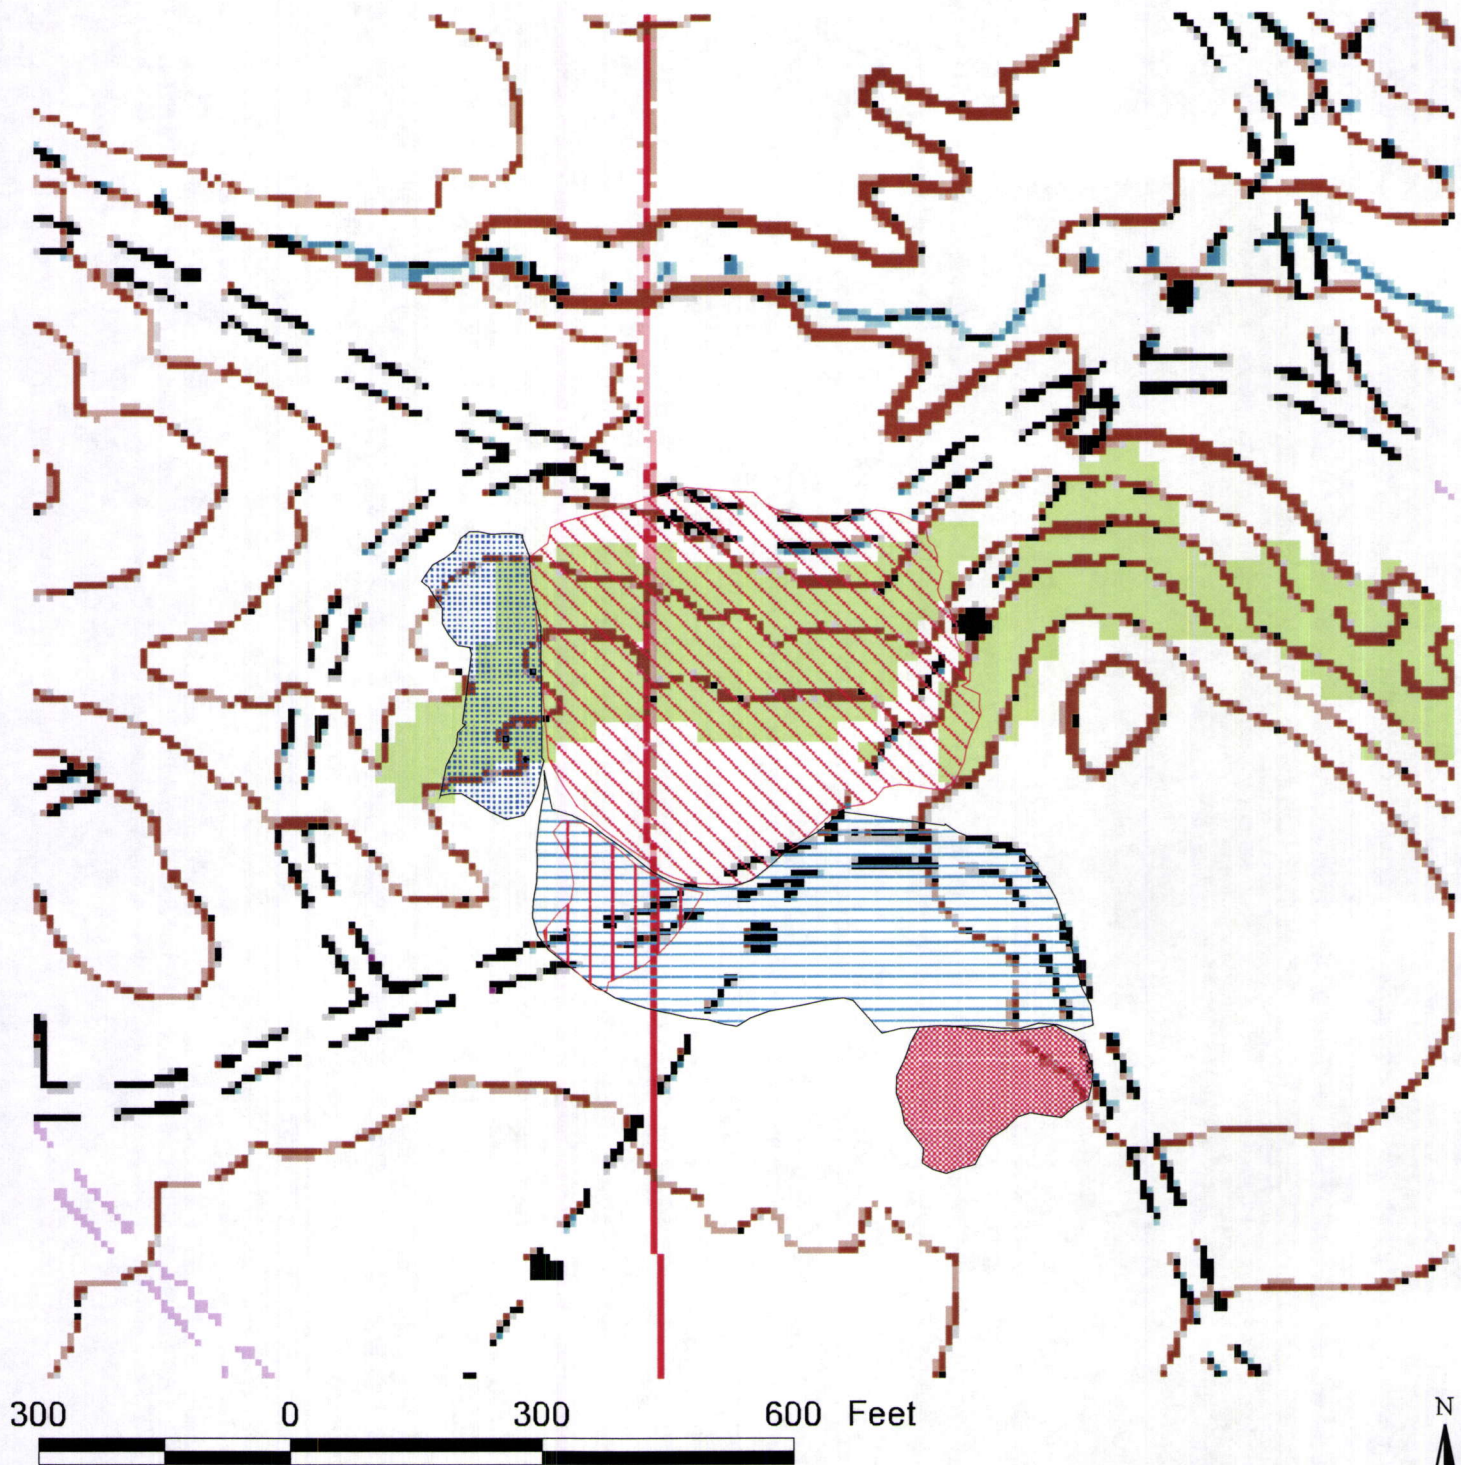
# Wemboco Mine S/C 17/068

## Disturbed Areas

- Processing, 2.93 acres
- Mixing area, 0.48 acres
- Reclaimable area, 0.76 acres
- Recycling area, 0.64 acres
- WEMBCO Mine, 4.38 acres

Bonded areas outlined in red (4.86 acres)

Map created June 6, 2003, from data gathered by Paul Baker May 22, 2003. Vernal NW Quad, Township 4 South, Range 20 East, Sections 23 and 24, SLBM.

A copy of the map I created in May 2003 is attached to this report. I do not believe the size of the disturbance has changed since I last used the GPS to map the area, but the uses may have changed to some degree. Areas clearly within the Division's regulatory jurisdiction are the mine pit area itself (4.38 acres), the mixing area (0.48 acres), and the reclaimable area (0.76 acres) for a total of 5.62 acres. This is less than the area that could be covered by the existing bond, but it is within the category of a large mine which requires submission of a Notice of Intention to Commence Large Mining Operations (see further discussion under "Concurrent Reclamation" below).
